Thermal Bridging at Qloft as Compared with a Typical Apartment Building

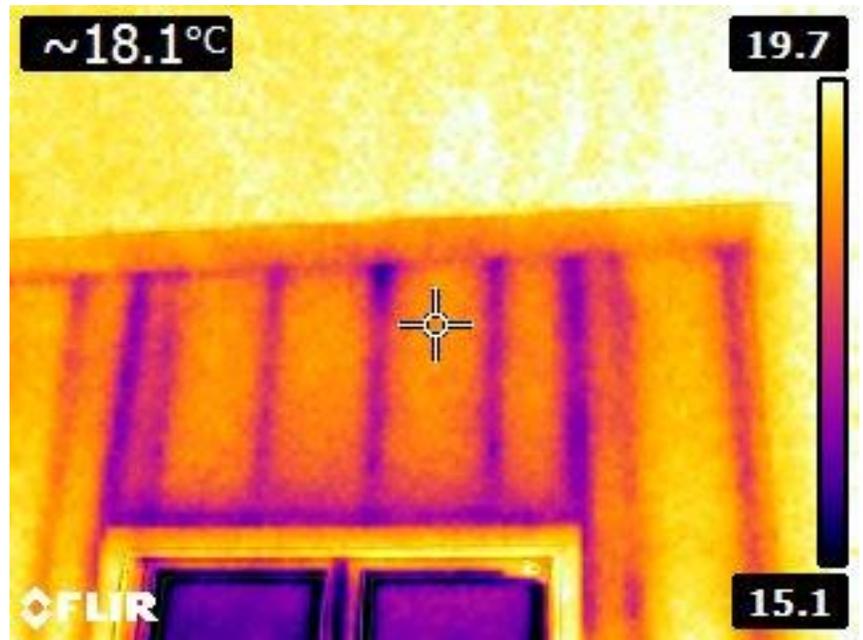
Shown in Figure 2 is a thermographic image of a well-constructed apartment building that meets the requirements of the National Energy Code of Canada. The image was taken on a cold day in March, 2017. The thermal bridge created by the steel frame shows prominently in dark purple. The cavity between the frame is insulated and therefore the surface temperature of the wall is much higher. There is a difference of 4C° between the coldest part of the frame and the rest of the wall.

Figure 2 – Thermographic Image of a Steel Frame Construction
Halifax, March 23, 2017

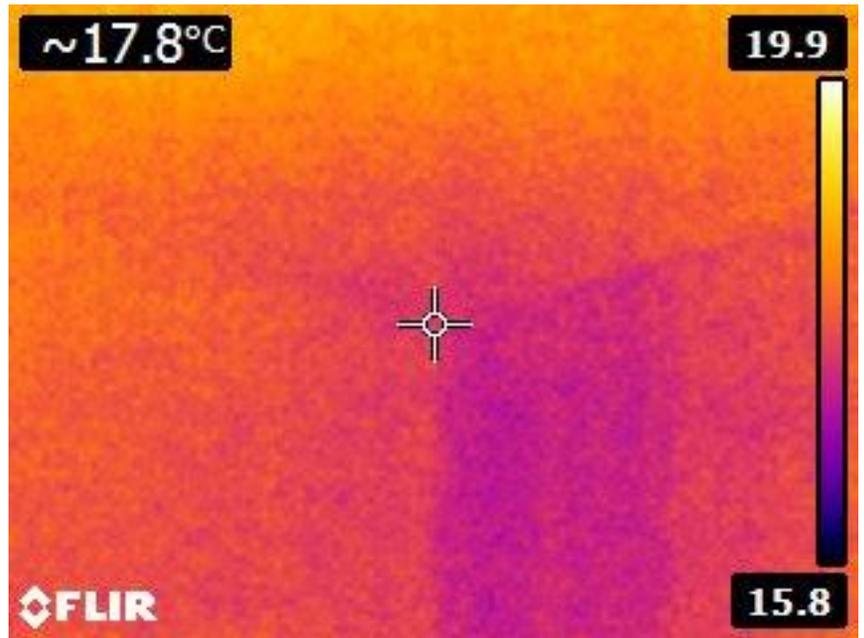
In an ICF wall, the structure is provided by concrete with a very small amount of steel added for reinforcement. While concrete is not the best insulator, unlike steel, it is not a conductor. The entire ICF wall has a continuous insulating value without thermal bridges. Figure 4 is a thermographic image of an exterior wall corner at Qloft. The image was taken on a cold day early in March, 2017. The colour variation is small when compared with the steel frame construction. Neither temperature extreme appears in the image. The temperature of the entire wall is 17.8°C with a small temperature variation of +/- 0.5C°.

Figure 4 – Thermographic Image Qloft - ICF Construction
Halifax, March 3, 2017

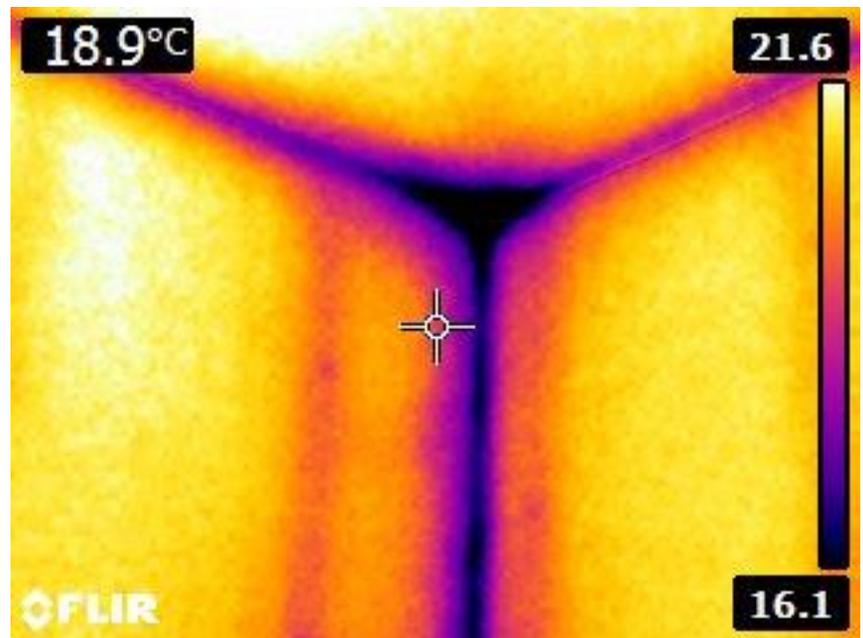
For one final comparison, a thermographic photograph was taken at a corner of a well-insulated energy efficient wood frame construction as shown in Figure 5. The image was taken on a cold day in March, 2017 for a house in Halifax. In this case, the wood frame forms the thermal bridge and has a much lower insulating value than the insulation. It is very clear in the image where the wood frame is located. The difference in temperature between the coldest and warmest surface in this image is 4.5C°.

Figure 5 – Thermographic Image Wood Frame Residence
Halifax, March 24, 2017
